Manhole Inspection Summary

Manhole # S41G__035MH

Insp Date: **5/18/09 9:46 AM**

Location Address: **110 S CENTRAL AV**

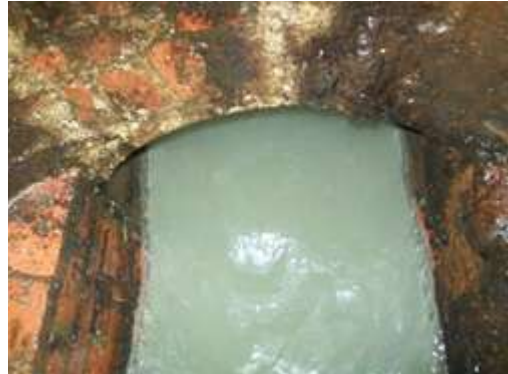
Defect 3

Infiltration: ☐ None ☐ Joint ☐ Cracks ☐ Mortar ☐ Roots ☒ **Wall**

INFILTRATION EVIDENCE OF BARREL WALL, ABOVE 5 OCLOCK

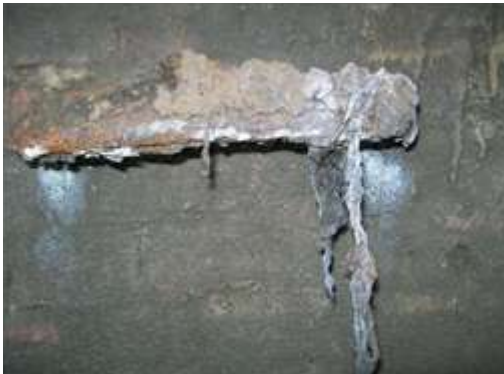
Defect 2

Surcharge ☒ **Evidence Of Surcharge** Depth: **6** (ft.) ☐ Active Surcharge Present

EVIDENCE OF SURCHARGE

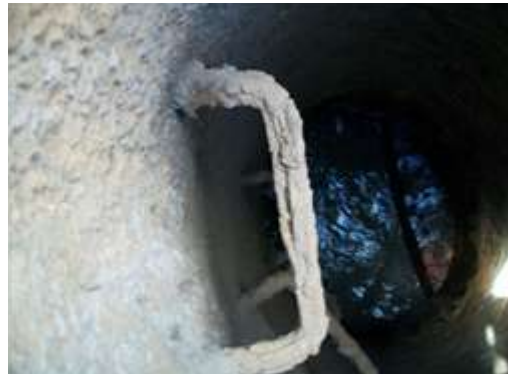
Defect 1

Steps Count: **7** Missing: **0** ☒ **Corroded**

CORRODED STEPS

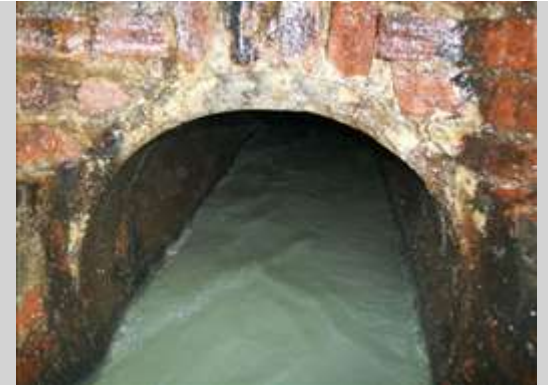
12 O'Clock Outflow

27 in. Circular Gravity Sewer
Pipe Out @ 12 O'Clock

Pipe Height: **27.6** (in.) Rod and Bar (Angled)
Pipe Material: **Clay** ☐ Pipe Lined
Invert Depth: **13.10** (ft.) Flow Characteristics: **Fast**
Deposits: ☒ None ☐ Mud ☐ Sludge ☐ Debris ☐ Grease
Silt Depth: **0** (in.) Deposits Extent:
Infiltration: **Evidence** Pipe Seal Cond: **Sound**

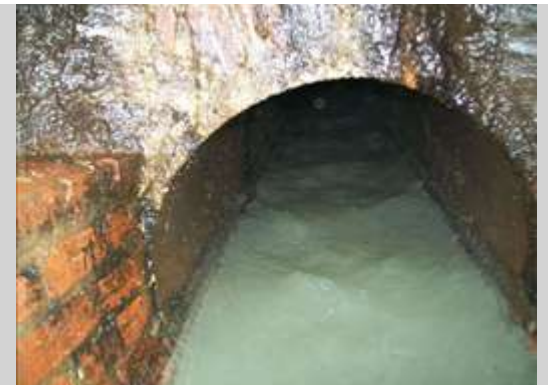
5 O'Clock Inflow

27 in. Circular Gravity Sewer
Pipe In @ 5 O'Clock

Pipe Height: **27.6** (in.) Rod and Bar (Angled)
Pipe Material: **Clay** ☐ Pipe Lined
Invert Depth: **12.93** (ft.) Flow Characteristics: **Fast**
Deposits: ☒ None ☐ Mud ☐ Sludge ☐ Debris ☐ Grease
Silt Depth: **0** (in.) Deposits Extent:
Infiltration: **Weeper** Pipe Seal Cond: **Unknown**
